Roof Inspection Report- Sample

| Address: Broad St, Augusta GA | |

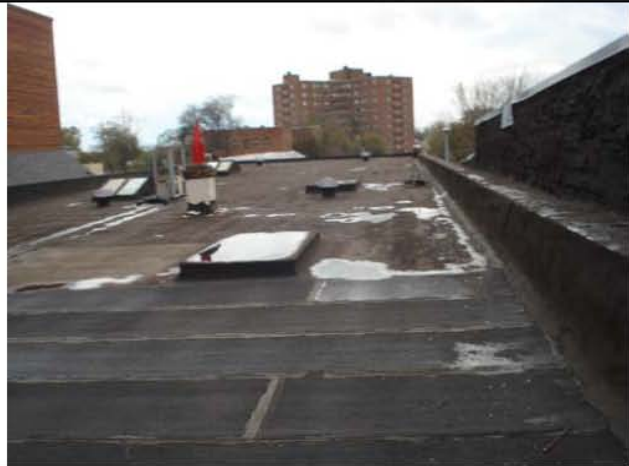
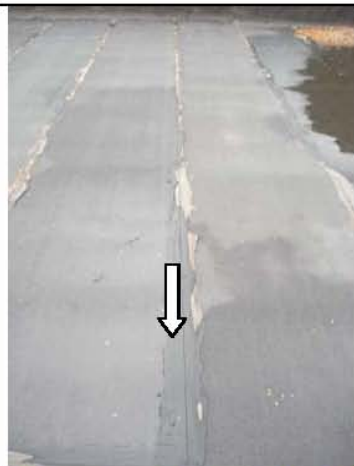
The field of the roof towards the front of the building has had modified bitumen roofing installed over the existing roof.

The seams on the modified have been sealed using roof cement. These seams should be heat welded and probed for tightness.

Recent repair attempts were made on the seams again using new roof cement.

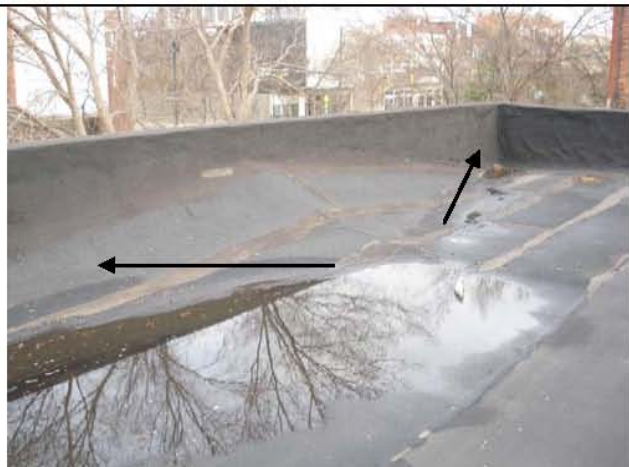
The water is diverted off the roof by a cricket to two through wall scuppers.

These scuppers are the most vulnerable part of the roof and the area with the most active leaks currently.
